# Stormwater Evaluation

## Crosstown Canal

Village of Potsdam

July 2018

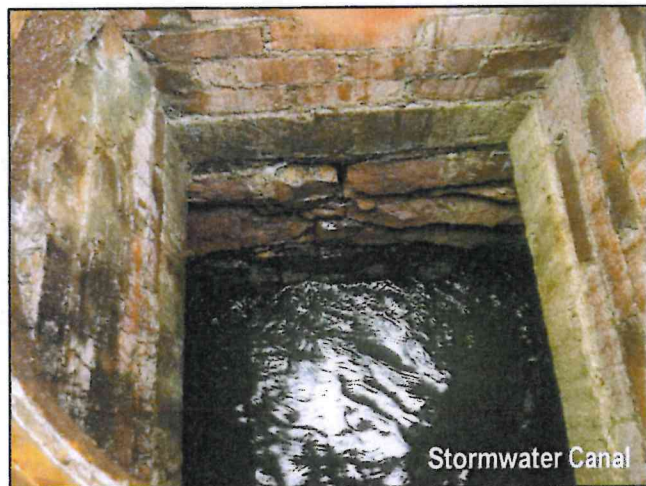
The Crosstown Canal System drainage area is approximately 800 acres with approximately 550 acres draining into the Village's stormwater collection system from the Town of Potsdam. Two stormwater entrance headwalls are located at the north and south ends of Potsdam High School. The influent headwall located to the north feeds a 4-foot tall by 4-foot wide canal section, which ties into the main line at the intersection of Market

Street and Canal Street. To the south, the headwall feeds a 40-inch reinforced concrete pipe (RCP) and is the beginning of the Crosstown Canal System, which continues to the intersection of LeRoy Street and Clinton Street. At the intersection of LeRoy and Clinton Streets, the canal widens to 16-feet wide and 4-feet tall. At this location, stormwater runoff from the 40-inch RCP is combined with runoff collected from LeRoy Street to the south and Clinton Street to the east, which are identified as sub-watershed Nos. 3 and 4 and are shown on Figure 2. Stormwater is conveyed approximately 135-feet, at which point the channel transitions to dual 40-inch RCP for the next 360-feet until it reaches Broad Street. The dual 40-inch RCP discharges to an 8-foot

wide by 3-foot tall sandstone channel 1,500 feet in length. This channel continues west along Broad Street, north on Waverly Avenue, and west along Pleasant Street and through private properties until it reaches Market Street. Runoff from sub-watershed Nos. 1 and 2 is collected in this section of the channel. The sandstone channel expands along Pleasant Street to a 12-foot wide by 4-foot tall section and continues 650-feet where it is intersected by another channel. At this intersection, the channel expands once again to a 16-foot wide by 4-foot tall section, which extends 675-feet to the discharge point at a channel invert elevation of 395.7 near the Raquette River. An open stone and earth channel then extends to the Raquette River.

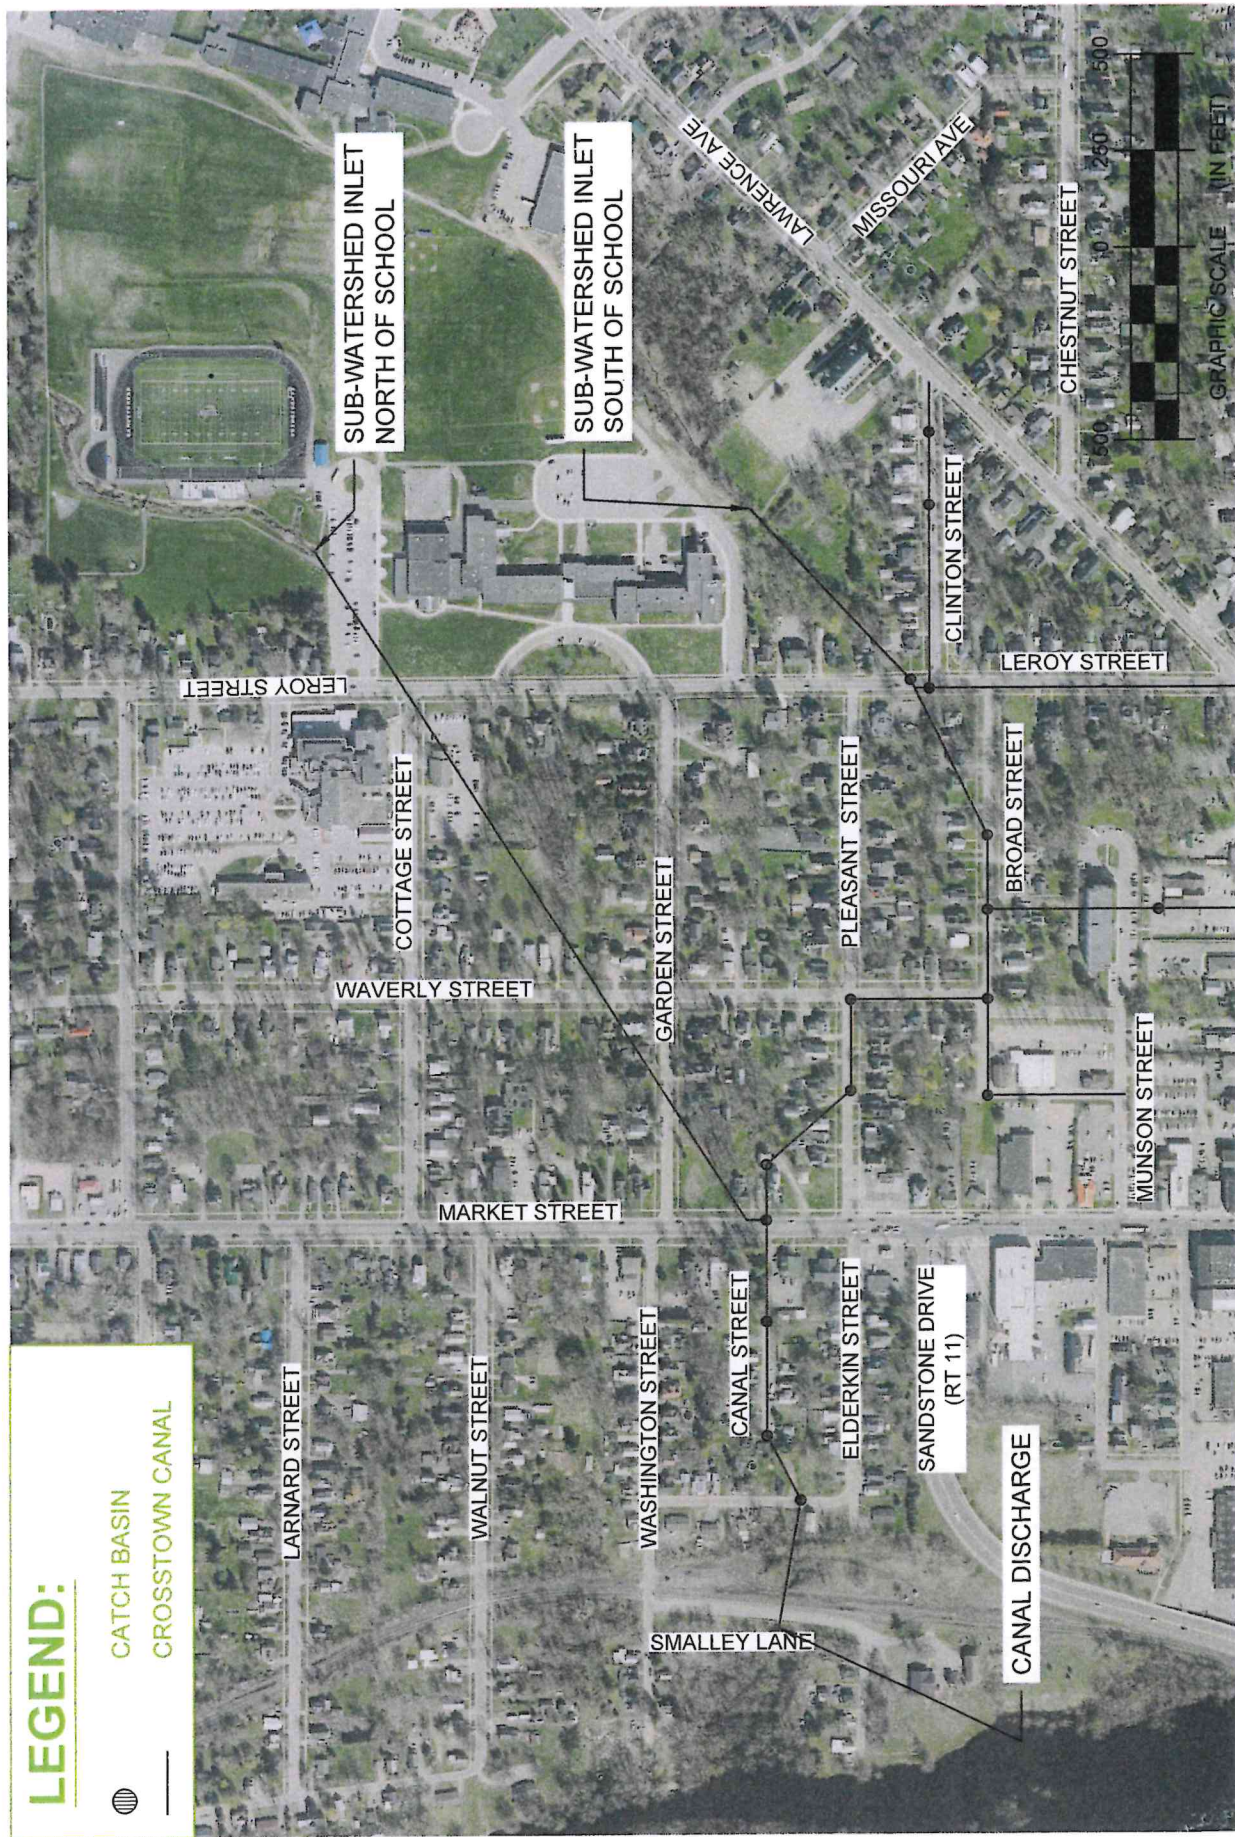
DRAWING NUMBER: FIGURE 1

DRAWING TITLE: CROSTOWN CANAL SYSTEM

The Village of Potsdam's Crosstown Canal was built in the early 1900's and serves a drainage area of approximately 800 acres which is divided into six sub-watersheds. The Crosstown Canal is located below grade within the Village limits and begins south of Potsdam High School and continues along Broad Street, Waverly Avenue, Pleasant Street, Market Street, and Canal Street and ultimately discharges to the Raquette River. An outline of the Crosstown Canal System is shown on Figure 1.

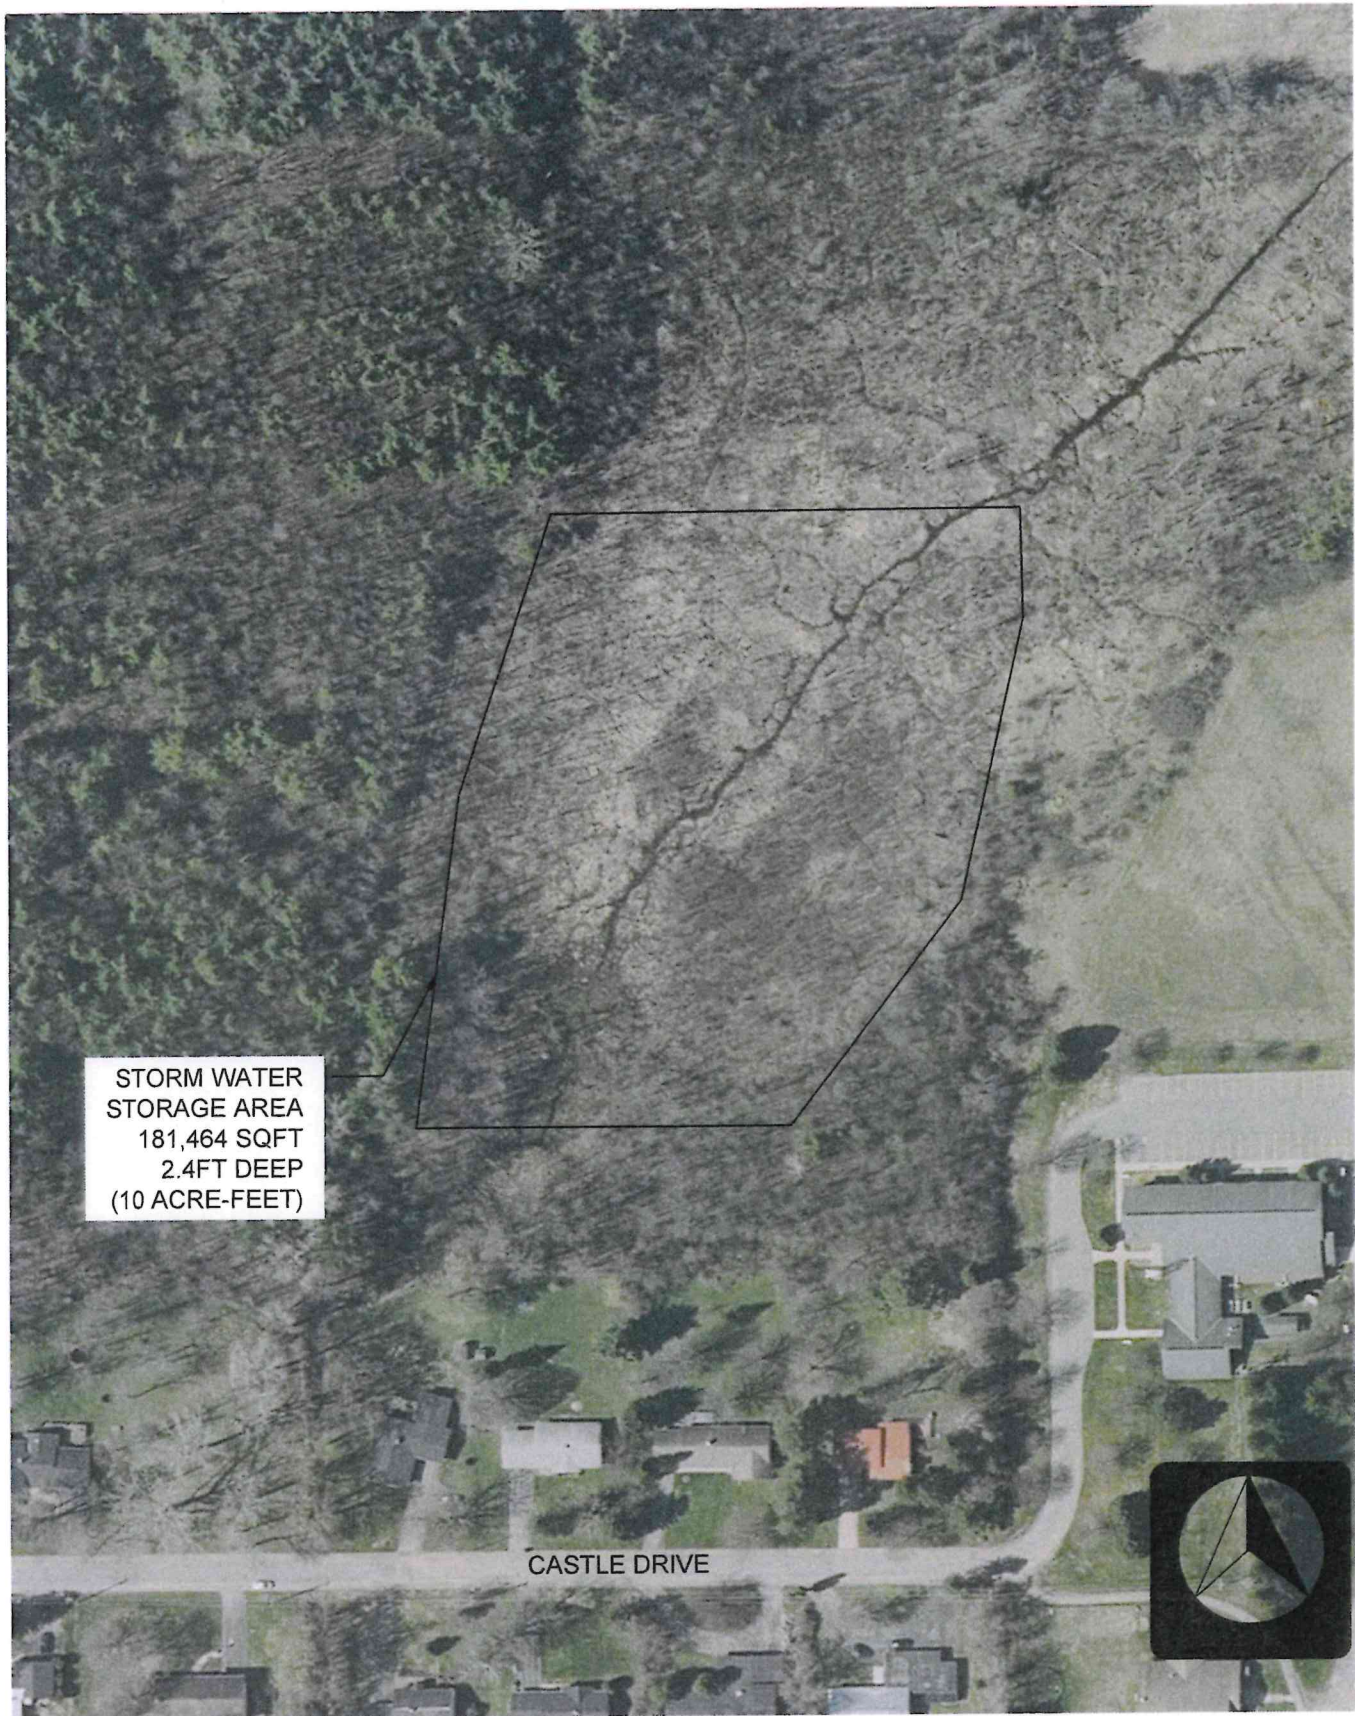
STORM WATER  
STORAGE AREA  
181,464 SQFT  
2.4FT DEEP  
(10 ACRE-FEET)

- 1) Stormwater Storage Areas – Installation of two stormwater storage areas at the north and south ends of the Potsdam High School property will serve to mitigate the peak rate of runoff entering the stormwater canal during a rain event. Controlled outlet structures will be installed to reduce the inflow to the Crosstown Canal from these areas for an anticipated period of 6-hours allowing the rainfall from the remaining four sub-watersheds to be discharged by the Crosstown Canal.
